## Overview

The Nevada Gold Fields, Inc. - now closed Barite Hill Gold Mine Project site - was one of four major mines in the South Carolina Slate Belt. It produced gold, silver and other minerals from 1991 to 1999. Ore was extracted from an open pit, crushed, treated, spread on leach pads, then sprayed with a cyanide solution to dissolve the gold. Waste water was recycled in the process, however, by 1994, the adjacent stream was devoid of fish and macroinvertebrates. Reclamation was attempted from 1995 until 1999, Nevada Gold Fields declared bankruptcy and turned over the property to the SC Dept. of Health and Environmental Control. By 2006, the pH of the water in the main pit had fallen to 2, the approximate acidity of lemon juice. Contamination had spread into the Savannah River and sites down river. Sporadic testing and site studies accompanied remediation efforts. In 2008, EPA added 1300 tons of hydrated lime to neutralize the acidic water in the Pit Lake. However, contamination persisted in the ground water. EPA placed the former Barite Hill mine site on the National Priorities List (Superfund) in 2009. Chapman et. al. wrote a USGS geologic report (2015) on various studies o

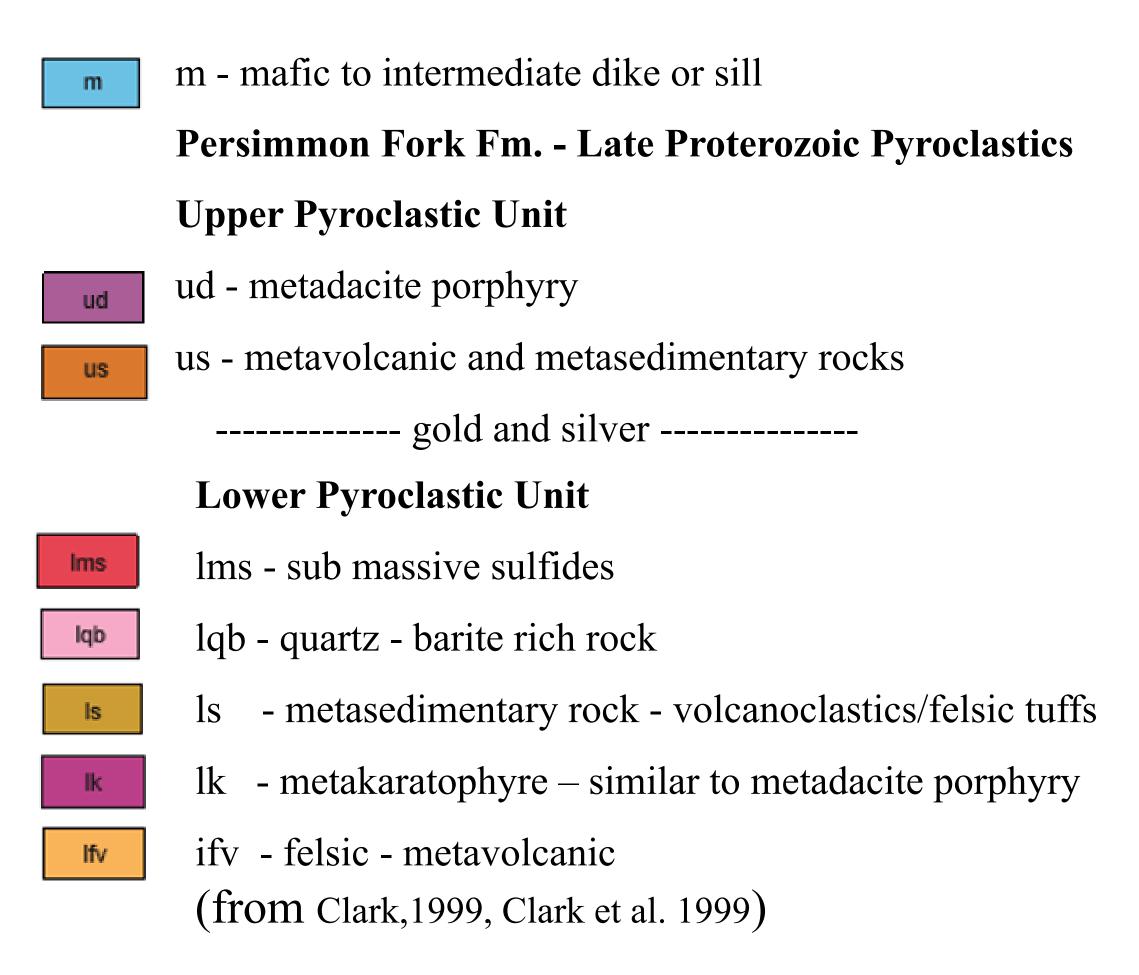
Barite Hill Geology "Metavolcanic – rock-hosted, stratiform gold-silver Deposit." Barite Hill gold and silver mineralized zone consists of 4 layers in the Main Pit area between the Upper and Lower Units of the Persimmon Formation, Late Proterozoic Pyroclastics. (from Clark, 1999, Clark et al. 1999)

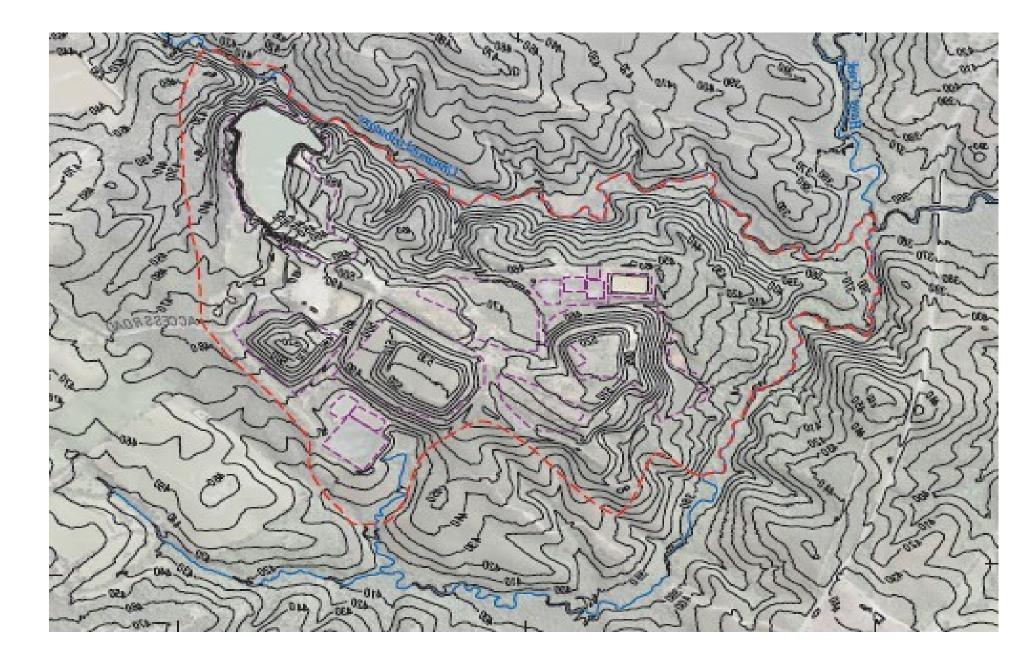
USGS Topo Contours—rolling forested hills reach to about 510ft along ridges. a (Chapman et al, 2015 and McBurney, 2007)

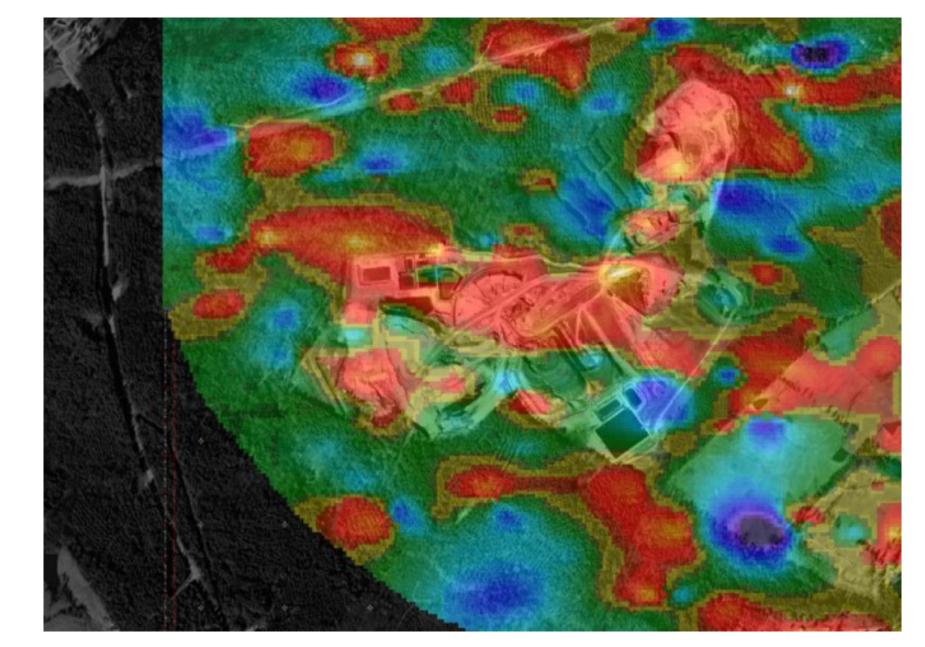
Apparent Resistivity Map over the former Barite Hill mine site

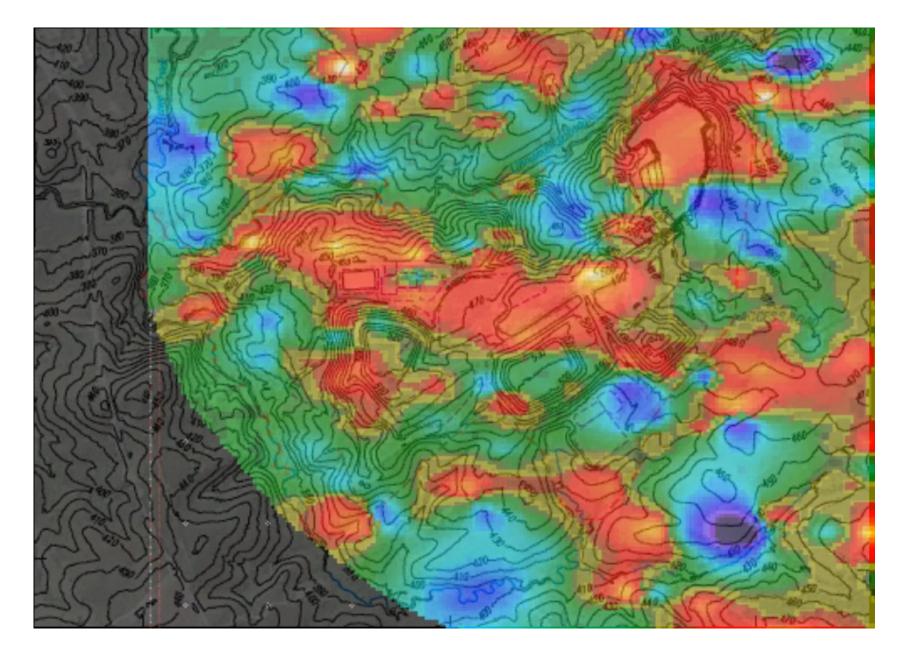
Apparent Resistivity Map over study area with USGS contours superimposed. (Chapman et al. 2015)

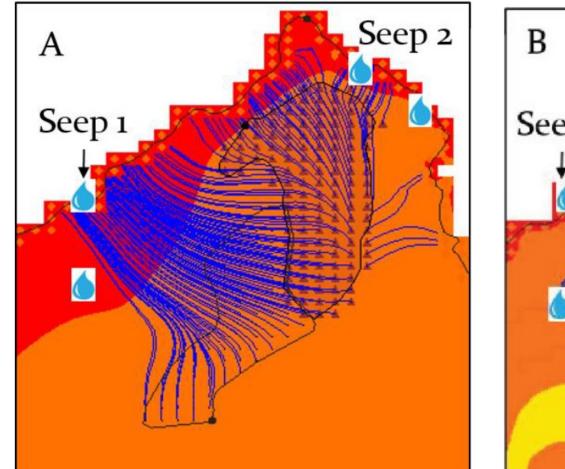
Flow Path Models: A - conventional model B - data enhanced model

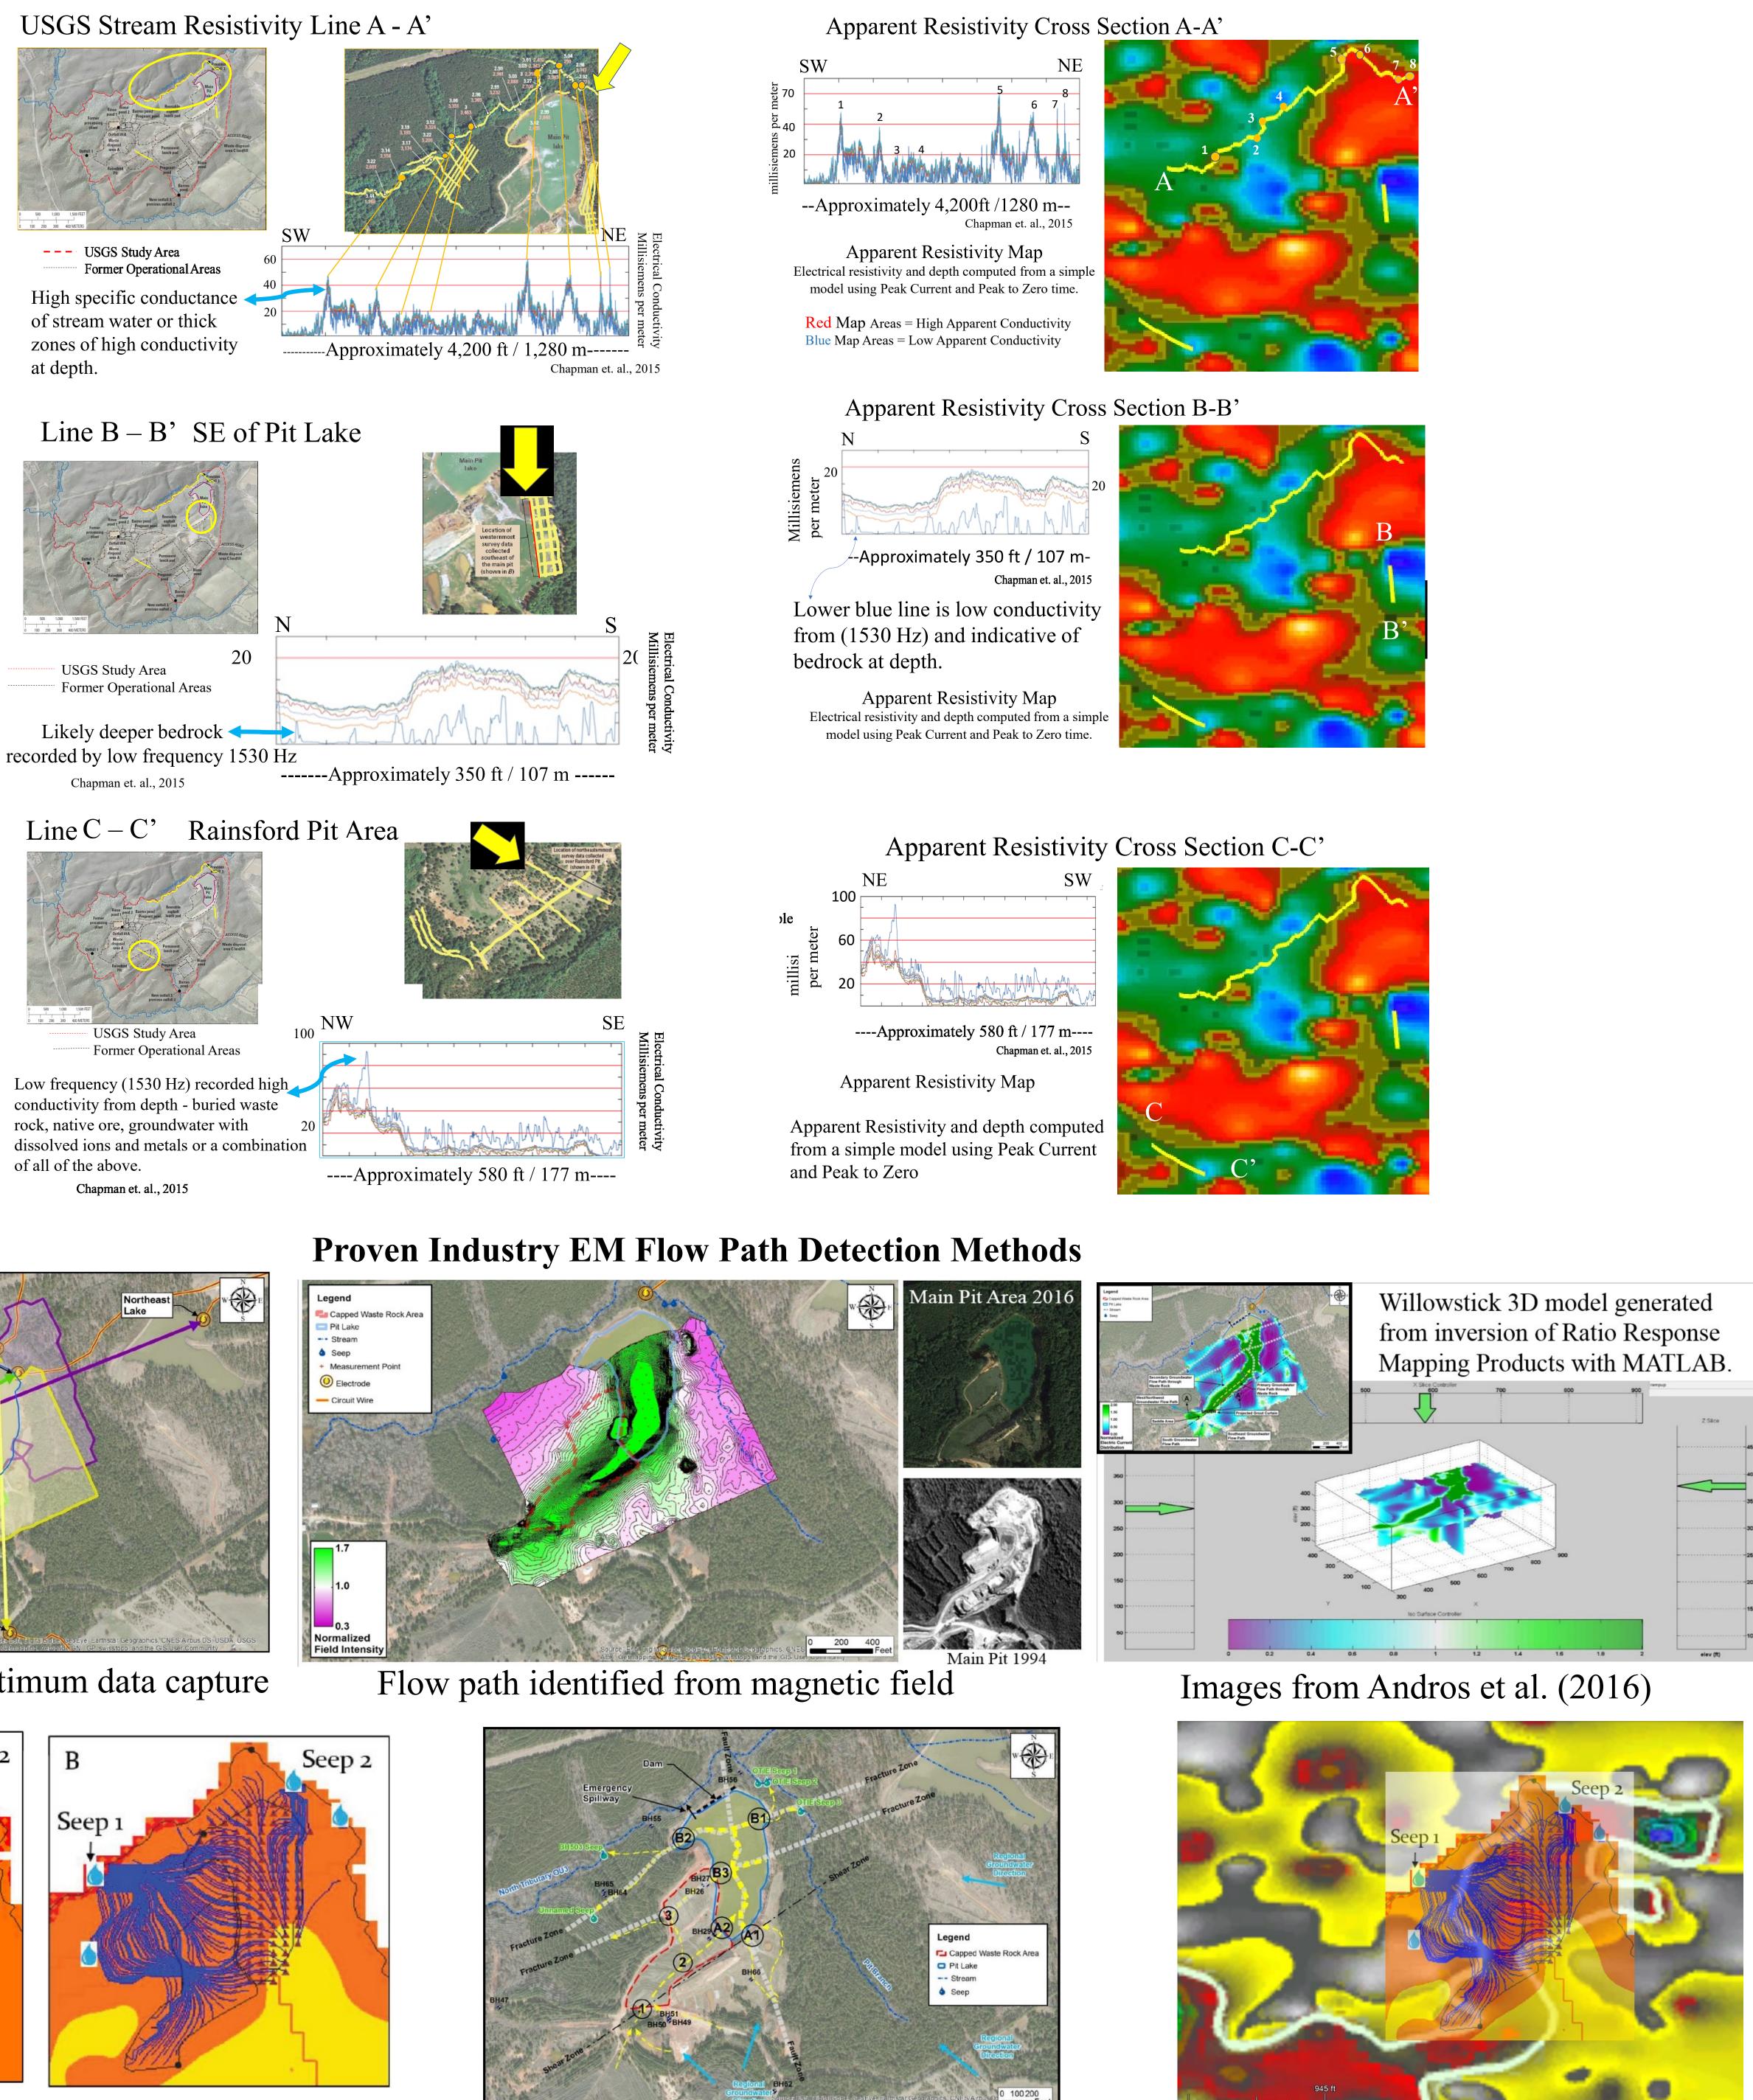
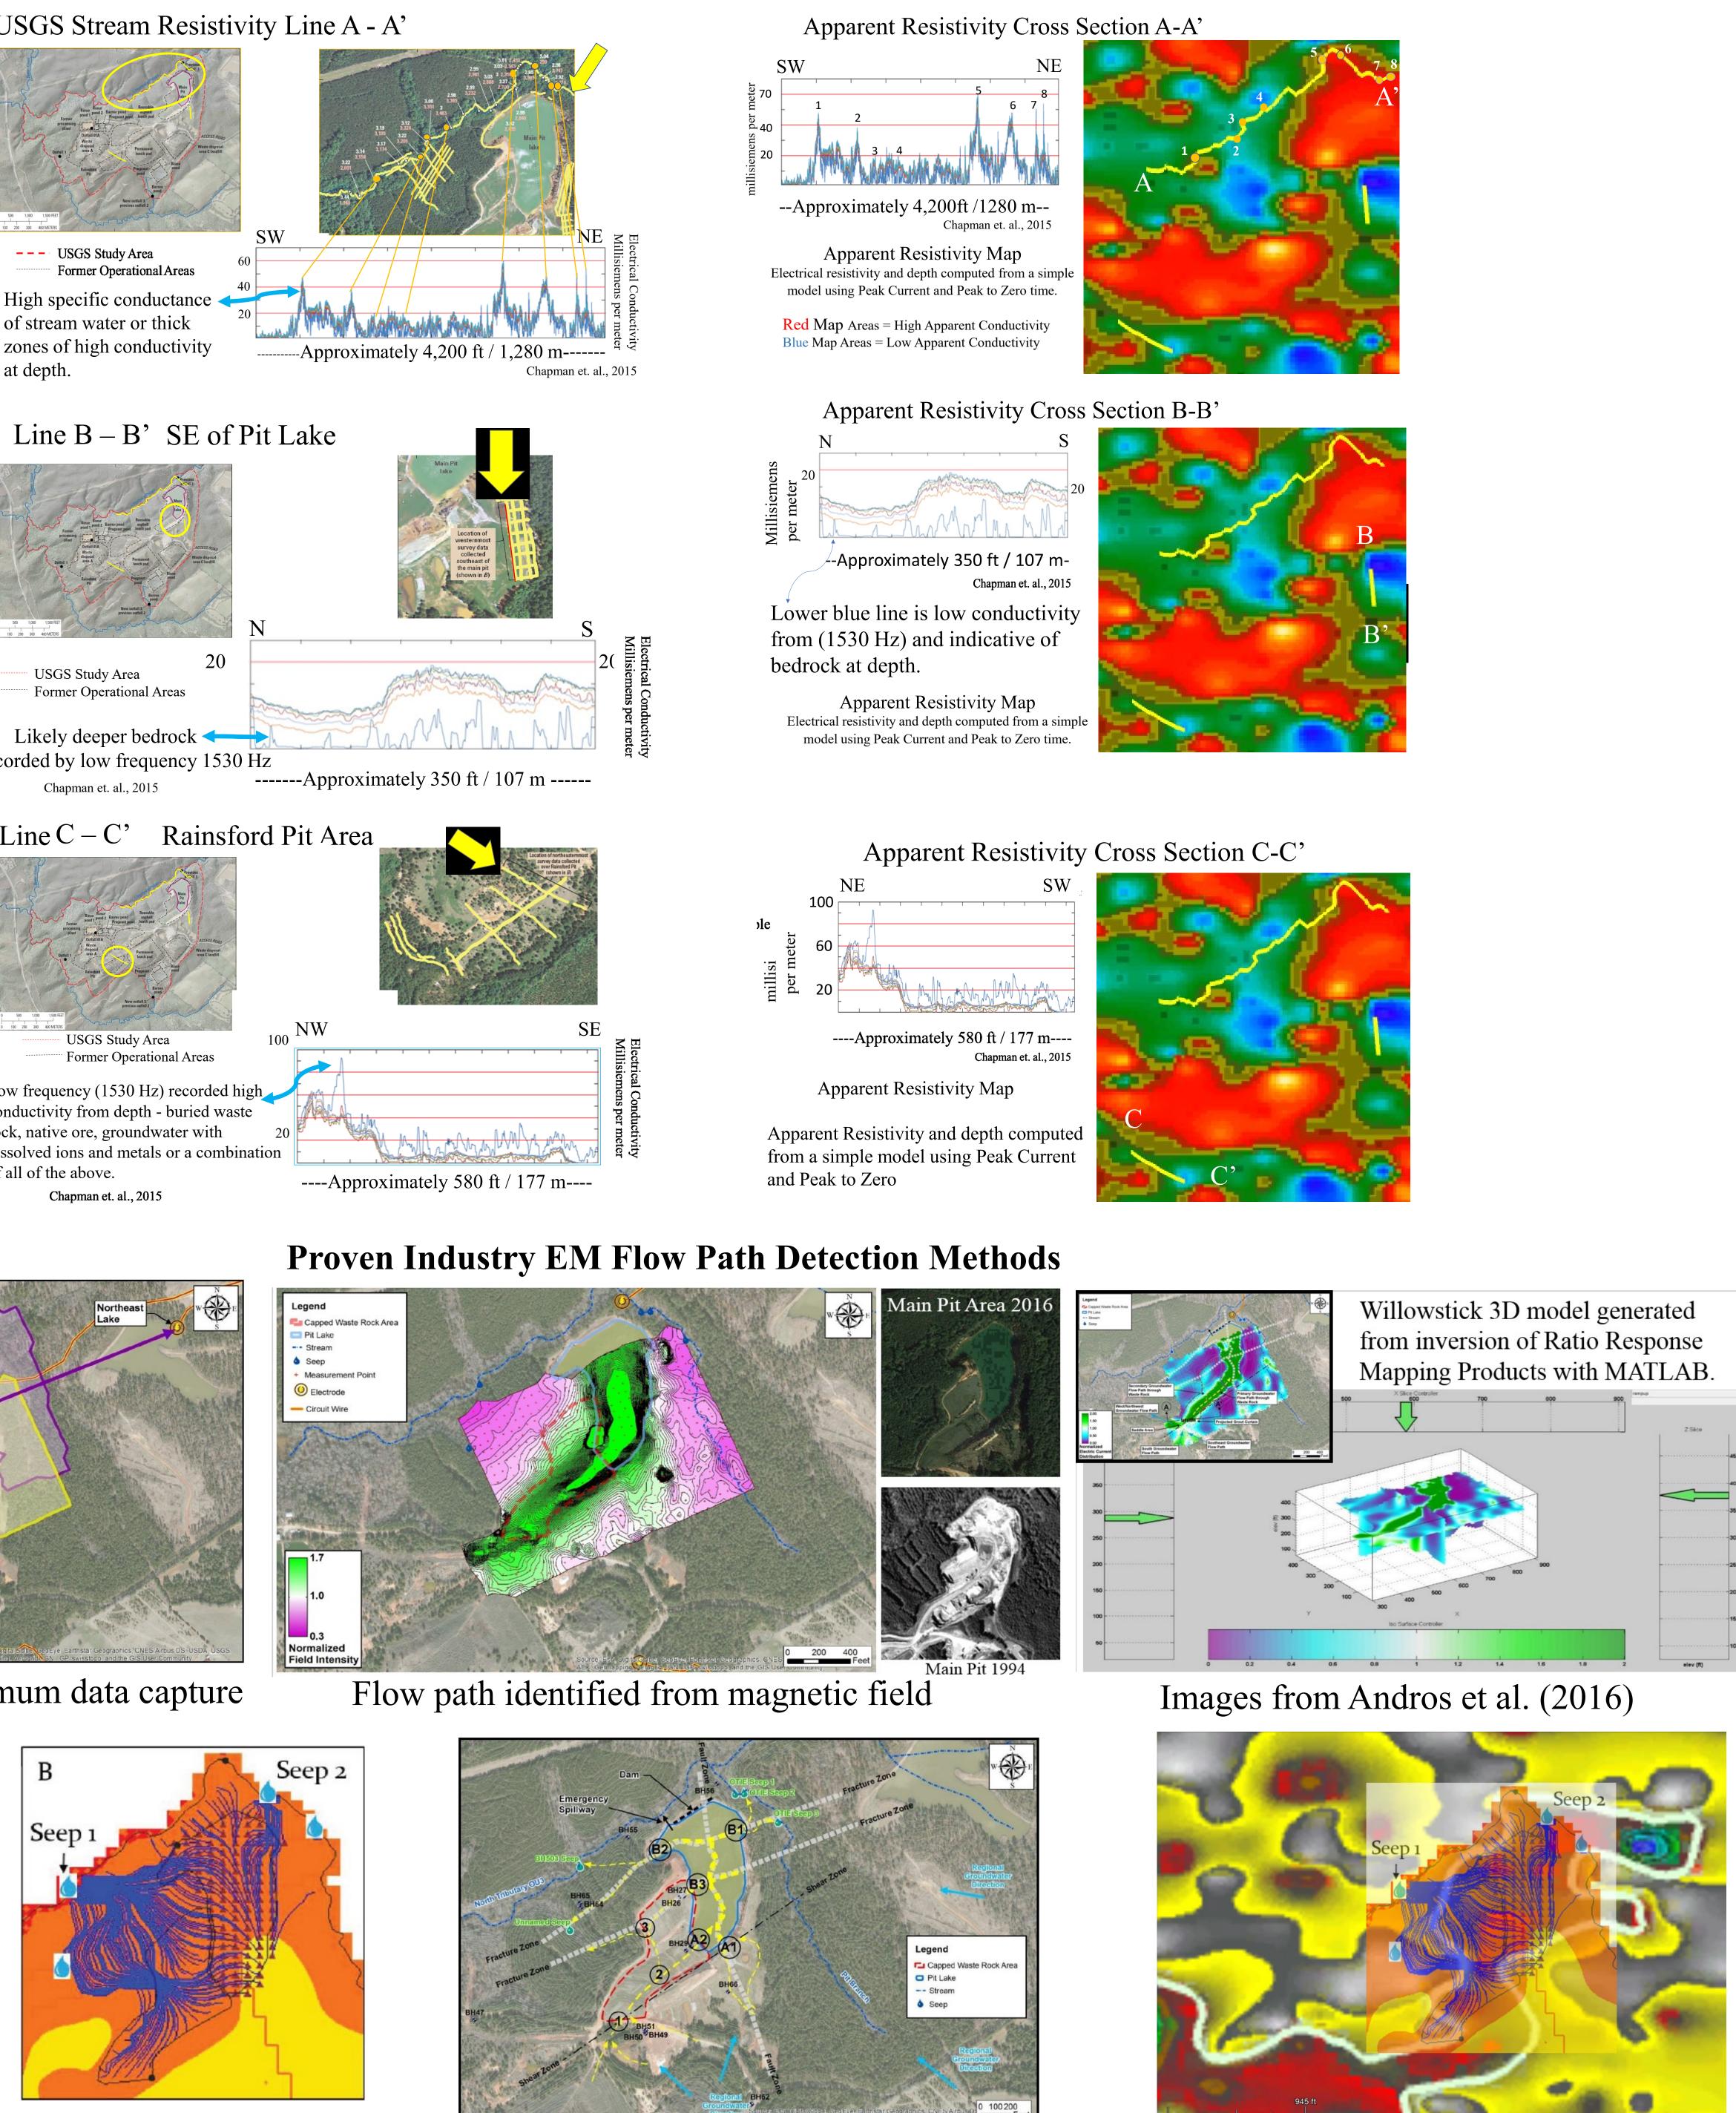
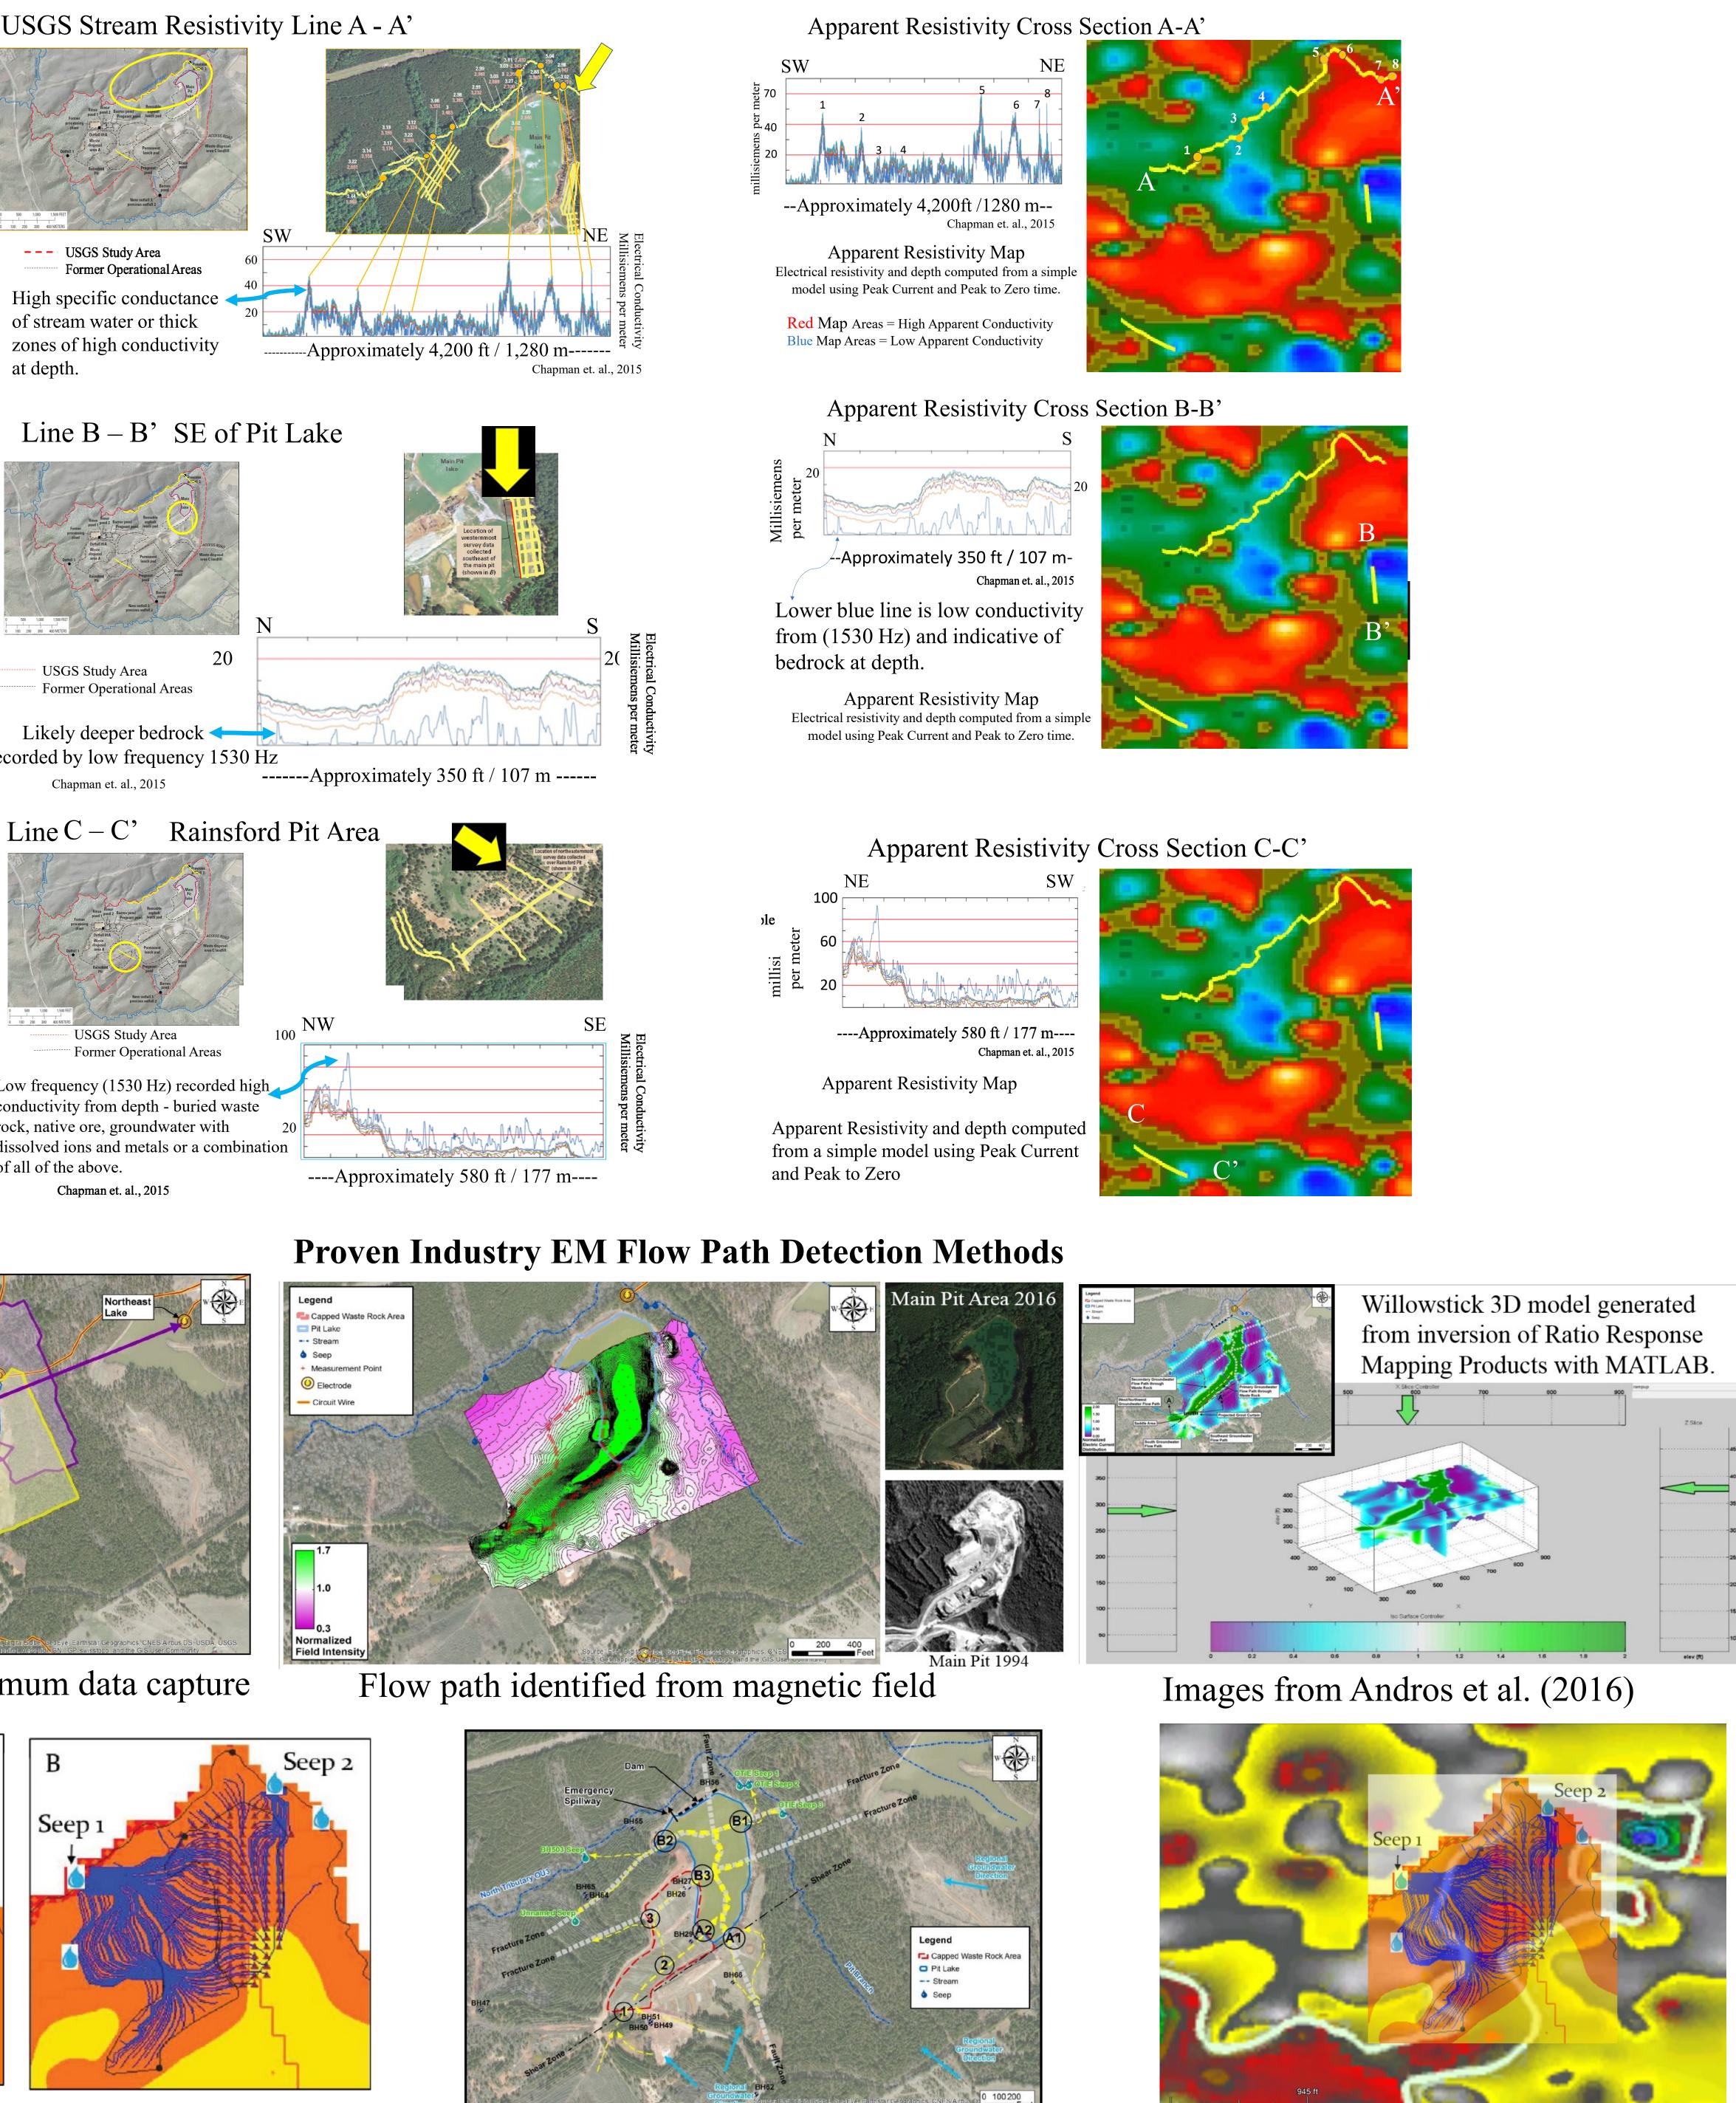
## USGS Conductivity Surveys –20012-20013 comparison with Apparent Resistivity Map Locations at Barite Hill - along unnamed creek north of the Main Pit, SE of Main Pit, and over the Rainsford Pit

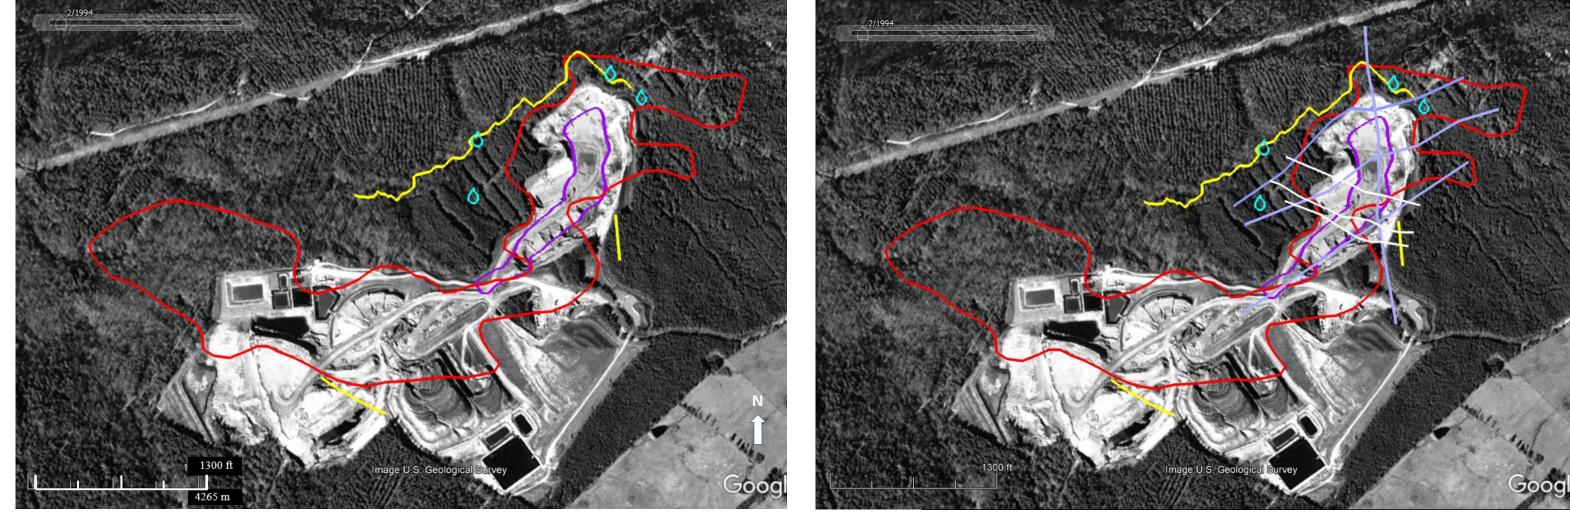
Enhanced Model overlay on Peak Current - Absolute

Red=Lightning Feature, Yellow=Conductivity Surveys, White=Faults, Blue= Fractures, Purple = Flow Path

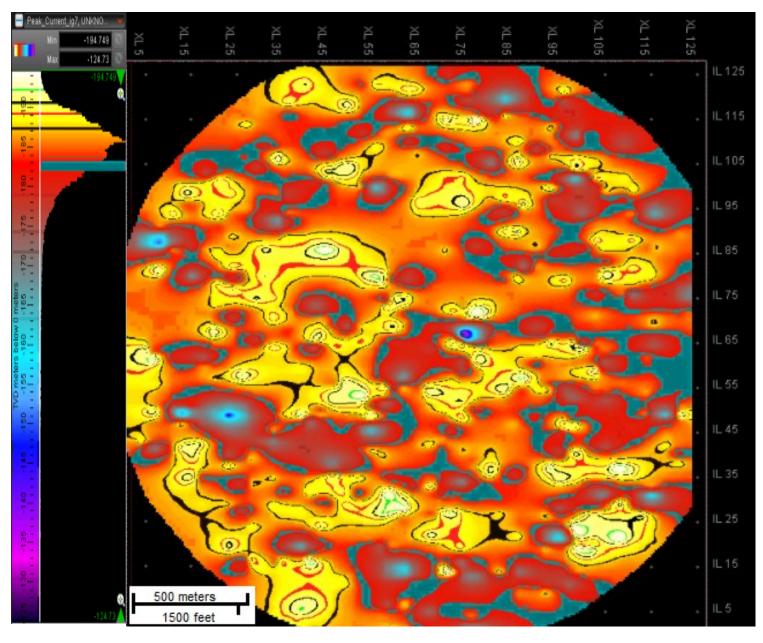
**Peak Current - Absolute** Peak current in kiloamperes

Similar patterns in 3 lightning attributes: Energy, Peak Current Absolute, and Apparent Resistivity Note location of Flow Path. High Apparent Conductivity (Right – Red areas) could indicate areas with contaminated ground water, conductive minerals/gold ore, or waste rock. Basement is high resistivity.

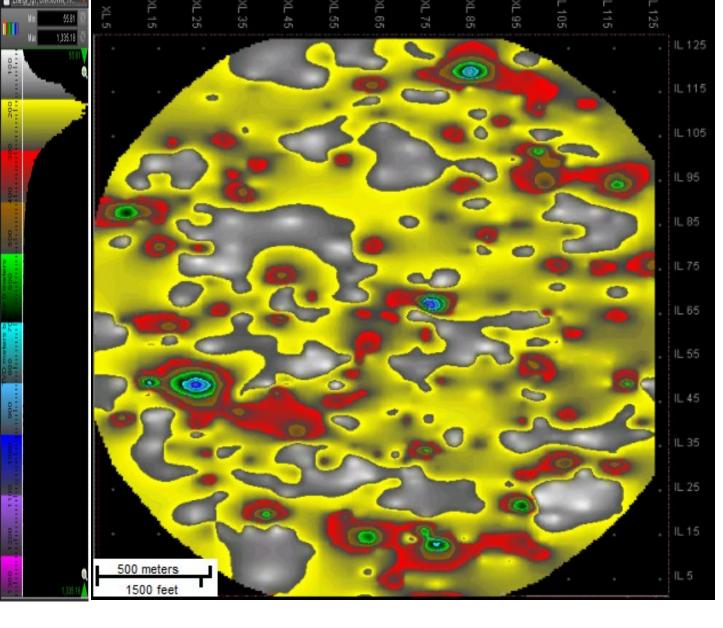
Energy [pc \* (rt+pz)/2] milliampere-seconds

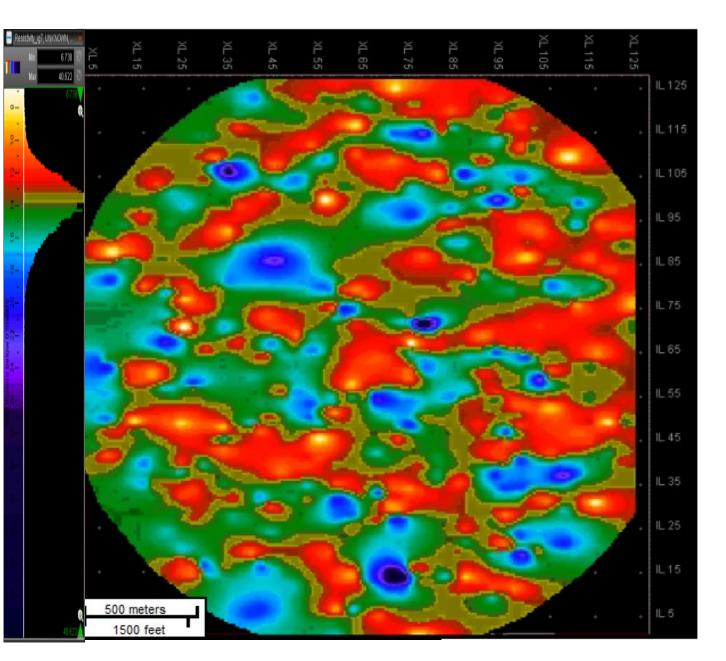
**Apparent Resistivity** Scale in ohm-meters
