## Coastal Land Loss and Landscape Level Plant Community Succession: An Expected Result of Natural Tectonic Subsidence, Fault Movement, and Sea Level Rise

Kathleen S. Haggar

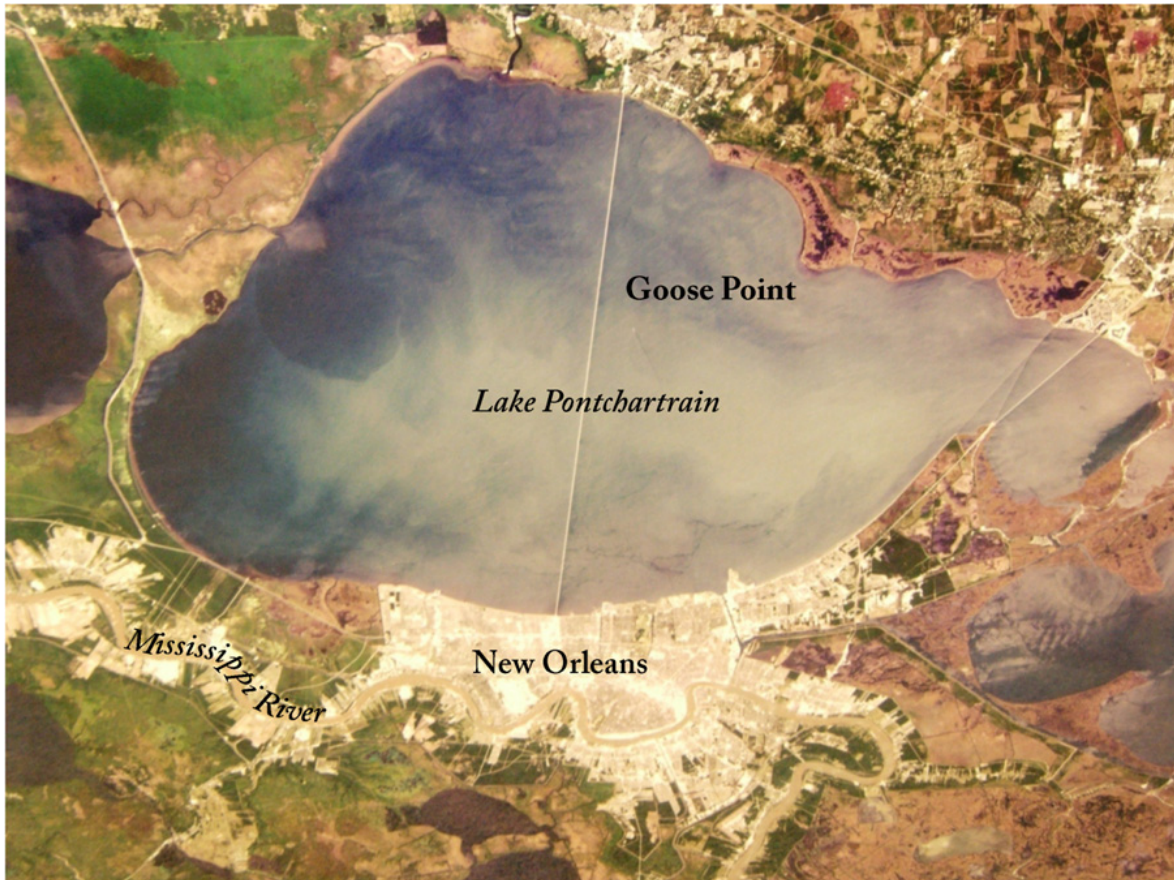
**Figure 1.** This is a 1993 NASA Satellite Earth Imagery aerial image, covering Lake Pontchartrain and vicinity. Note the similarity of the marshes along the north shore, with the marshes in the southwestern part of the photo between the Mississippi River and Lake Borgne. Those degraded marshes are part of the Biloxi Marshes and Central Wetlands of St. Bernard (NASA, 1993).

Goose Point is located just south of Lacombe, Louisiana, on the north shore of Lake Pontchartrain, referred to in this paper as the Lake. The Lake is actually not a Lake, but a Bay in open communication with Lake Borgne and the Mississippi Sound, chiefly through the Chef Menteur and the Rigolets passes, with the Inner Harbor Navigation Canal playing a very minor role (Georgiou et al., 2007). This paper focuses primarily on the area of Goose Point west of Bayou Lacombe between the Lake and the onshore Lacombe fault segment of the Baton Rouge Fault System; see Figure 1.

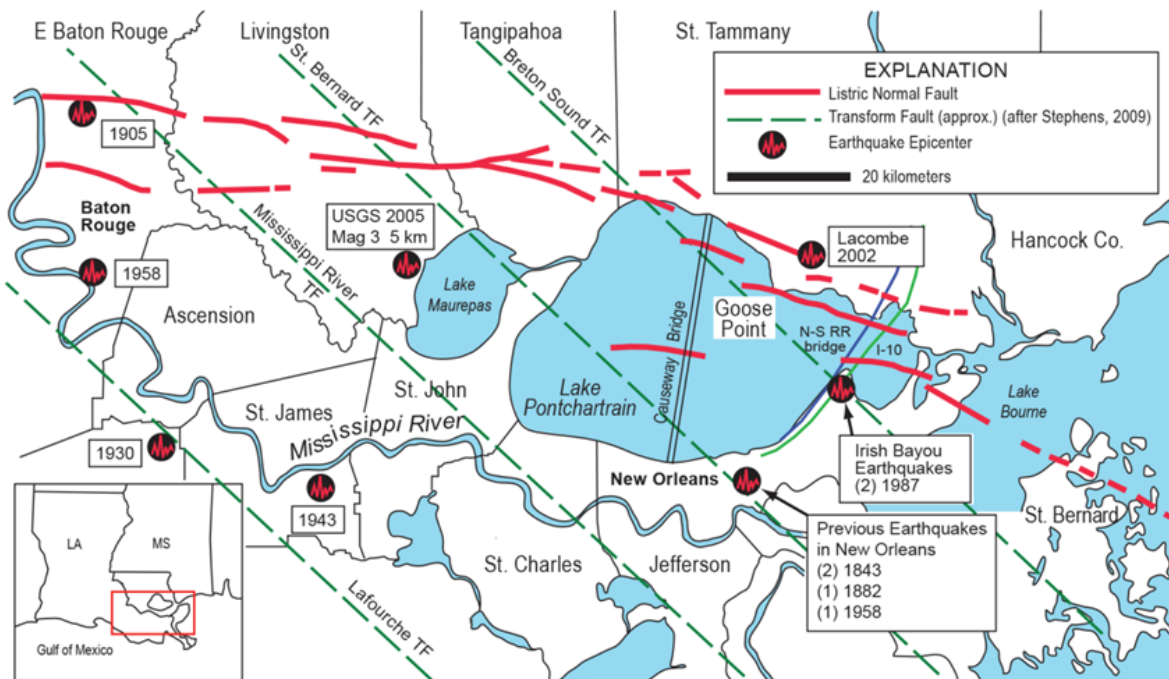
**Figure 2. Regional tectonic setting for Goose Point.** This figure serves as a reference for discussion on faults, earthquakes, and transforms in a regional perspective around Goose Point. This map does not show all faults or transforms present. The *Environmental Atlas of the Pontchartrain Basin* (Penland et al., 2002) illustrated 5 faults in Lake Pontchartrain as extensions of the Baton Rouge–Denham Springs Fault System. The 4 segments along the north shore from west to east are Madisonville Point Fault, Causeway Fault, Goose Point Fault, and South Point Fault (Kulp et al., 2002). The onshore fault segment of interest, the Lacombe Fault, is named here and was mapped by Heinrich (2004). Earthquake data are after Gagliano et al. (2003), with data added by Haggard from USGS (2005) near French Settlement. The transforms depicted are after Stephens (2009, 2010).

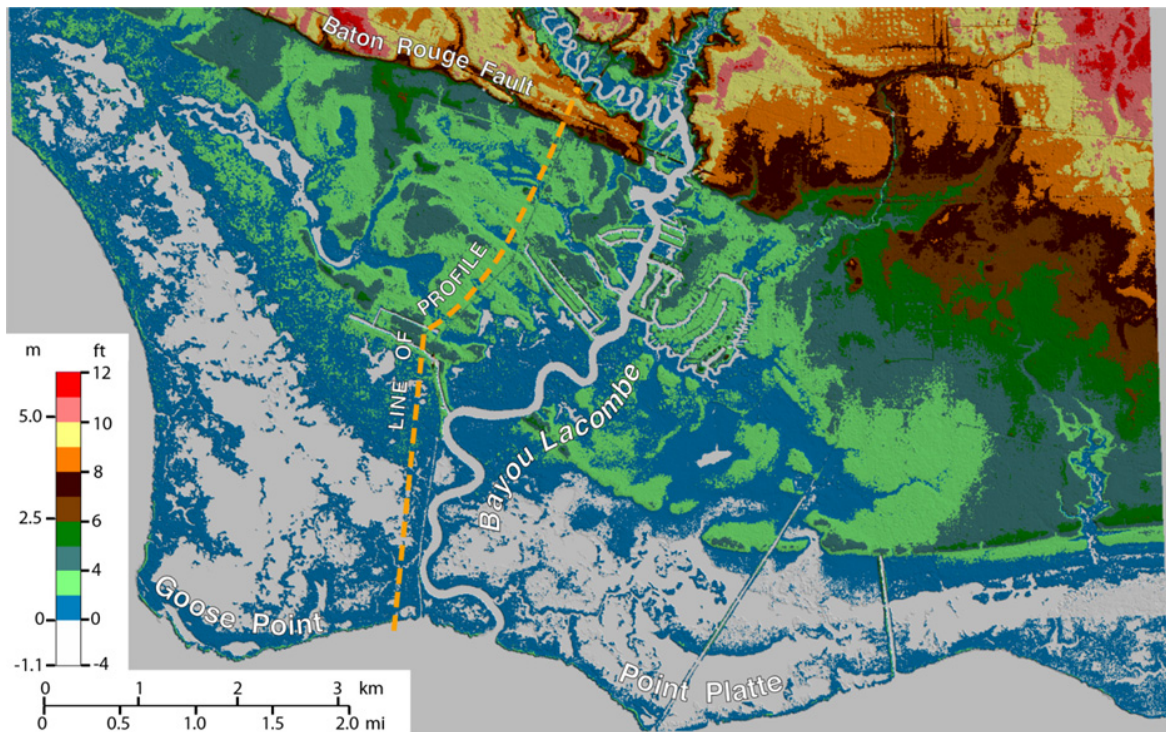
**Figure 3. Goose Point LIDAR Map (Lacombe SW and SE LIDAR Panels) (Atlas 1999a, 1999b).** LIDAR shows the fault relief along the trace of the Baton Rouge Fault just south of the Tammany Trace linear park. The Lacombe Fault segment of the Baton Rouge fault dies out just east of Bayou Lacombe. The point to the east of Goose Point is Point Platte. The profile shown here (Fig. 9) is to the west of Louisiana Hwy. 434/Lake Road and travels through the eastern side of the subject area.

face fault feature defined by LIDAR (Fig. 3) and by LGS mapping as the Baton Rouge Fault System. The coring done by McCarty and Penland (2002) did not extend far enough to the north to capture the Lacombe Fault. Holocene movements along this fault system, as measured on structures in Baton Rouge and in Lake Pontchartrain from the 1950s to the present, demonstrate recent movement of 15.2 to 20.3 centimeters (6 to 8 inches) (McCulloh, 2001; McCarty and Penland, 2002). Movement on the Causeway Fault, Goose Point Fault, and South Point Fault is proven by damaged roads and bridges, seismic and/or vibracores. Movement on the Madisonville Point Fault is assumed as well. The Goose Point fault stretches approximately 27 kilometers (17 miles). Displacement on the Pleistocene is approximately 3 meters (10 feet) (Kulp et al., 2002). For many years, the presence of Pleistocene activity on growth faults was considered something of a geologic oddity that seemed mostly confined to the Baton Rouge Fault System (Durham and Peoples, 1956). In recent years, geologists have discovered that many of our coastal faults are showing their surface expressions and locally driving land change (Kuecher, 1994; Lopez, 1996; Kulp et al., 2002; Gagliano et al., 2003; McLindon, 2014).

At least four faults that are part of the Baton Rouge-Denham Springs fault system cross through Lake Pontchartrain. From northwest to southeast they are the Madisonville Point Fault, the Causeway Fault, the Goose Point Fault, and the South Point Fault (Kulp et al., 2002). These faults are still active as evidenced by offsets in the Causeway, the railroad bridge between New Orleans East and Old Slidell, the U.S. Hwy. 11 bridge, and the original Twin Span of I–10. (We can presume the Madisonville Point Fault would have shown movement but for the lack of structures.) Hurricane Katrina destroyed the shimmed part of the Twin Span in August of 2005, so the lost buckled eastbound guard rail just past the southern shoreline is no longer a tangible testament to fault activity. The Lake faults are still there and are probably still moving. The mapped onshore fault segments are very apparent on LIDAR; see Figure 3.

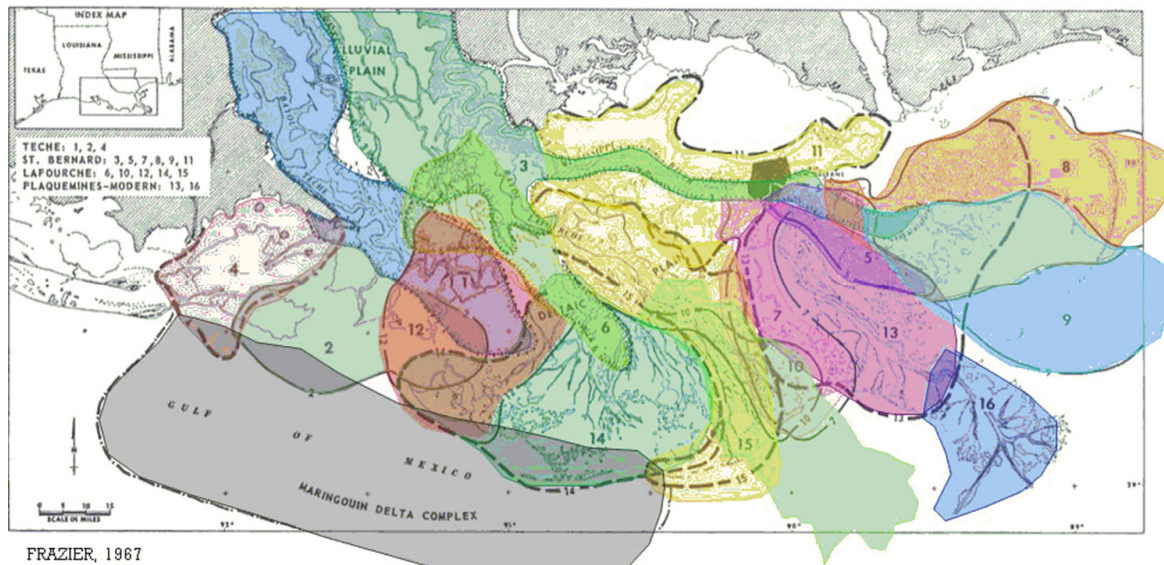
**Figure 4. Ancestral Mississippi River delta lobes (modified after Frazier, 1967; color added by McLindon, 2014)**

Figure 4 below is after Frazier (1967) and shows the location of Goose Point. Frazier, more than most, went into detail on the channels and lobes associated with each of the ancestral Mississippi River deltas in succession—16 of them in all. The closest delta to approach Goose Point was associated with the easternmost distributaries of the St. Bernard Delta. Two distributary channels diverted to the north towards the Baton Rouge Fault System. One went along the area that forms the land bridge between Lake Maurepas and the other formed the eastern New Orleans land bridge towards Slidell. These unusual north trending distributaries may have been “invited” by the zone of deformation associated with the Baton Rouge Fault System that helped to create Bay Pontchartrain/Lake Pontchartrain (Lopez et al., 1997; Sabate and Wiltenmuth, 2003). None of the ancestral deltas of the Mississippi River reached Goose Point, or the north shore of Lake Pontchartrain; see Figure 5. The Holocene sediments on the north shore are present only as a thin wedge, 2.5 meters (8 feet) or less, mostly south and downthrown to the fault line scarps that parallel the lake (McCarty and Penland, 2002). The closest delta to Goose Point was the Cocodrie, delta II. However, this delta was not preserved. It was the first delta to swing to the east side of the Mississippi River trunk channel. The St. Bernard, delta VIII, was the most recent and is still subaerial (Frazier, 1967)

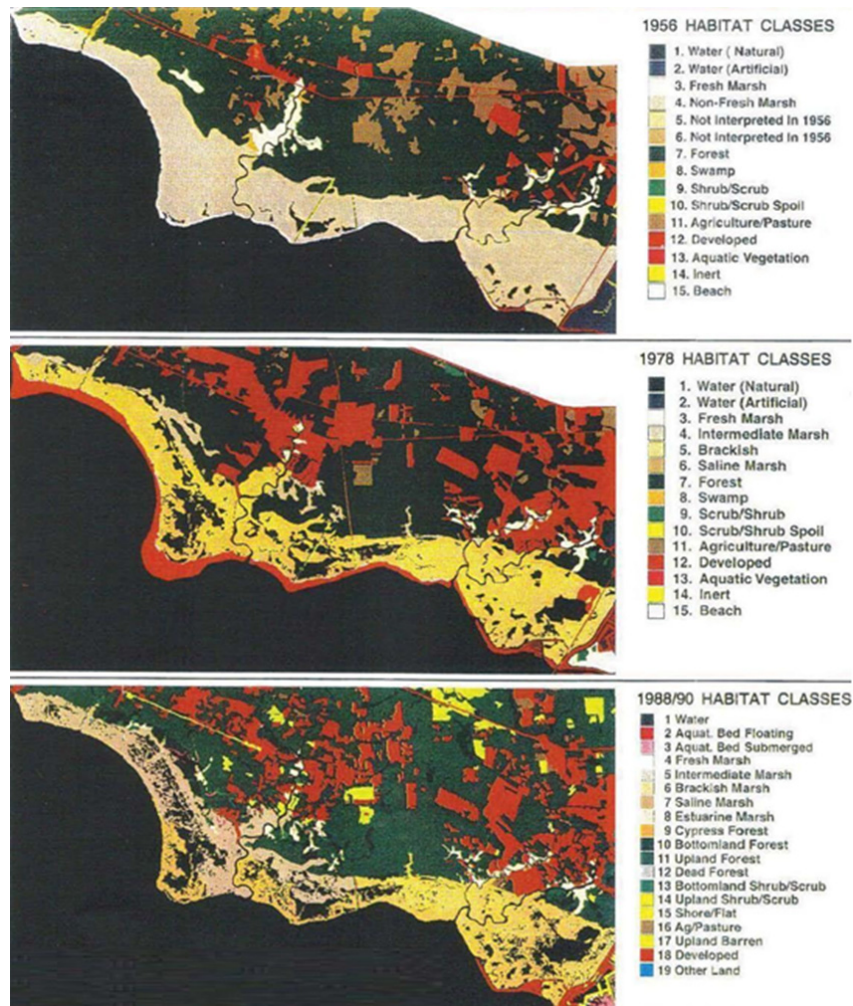
**Figure 6. Habitat classes for Goose Point, 1956, 1978, and 1988–90 (Chabreck 1956; Chabreck and Linscombe, 1978–80 and 1990; Wiltenmuth, 2000).**

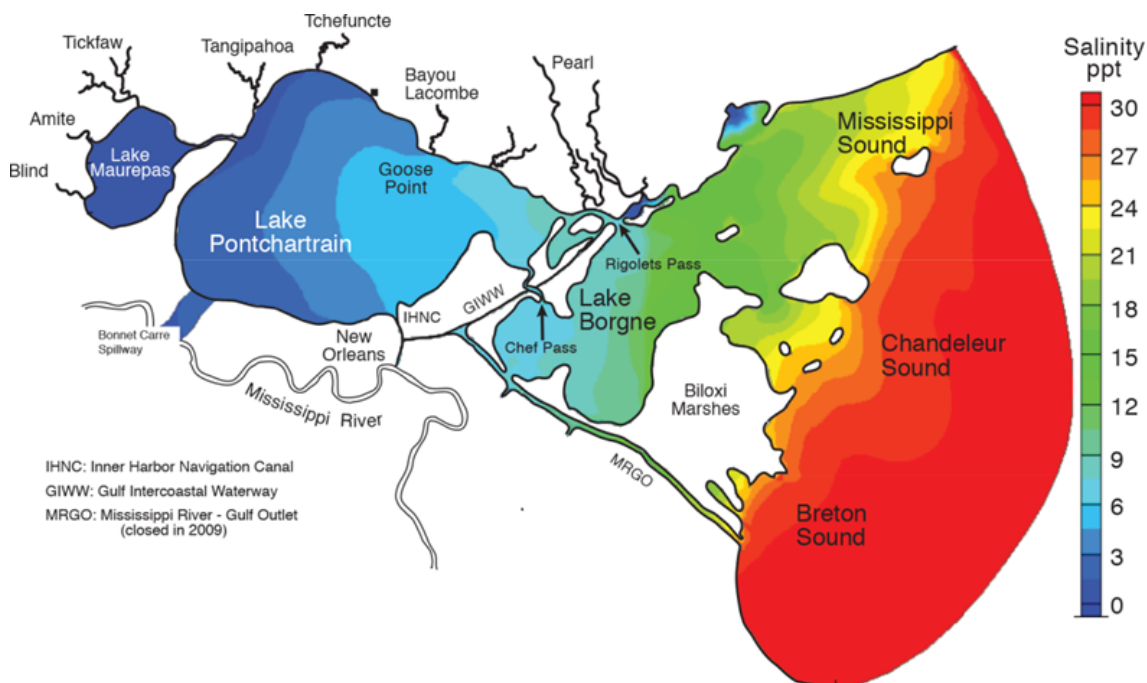
**Figure 7. Salinity gradient from Lake Maurepas to Breton Sound (modified after Georgiou et al., 2007). The map shows the area around Goose Point ranges in salinity from 3 to 4.5 ppt.**

In a place like the Goose Point marsh where factors such as soil, light, and nutrients have remained relatively constant, water becomes a critical determining factor in plant succession. Water at Goose Point is present along a salinity gradient and a depth that is related to slope and elevation. Variations in the topography and slope determine how long the water stays in a given area. Individual species have limits based on salinity and water depth. When the hydrology and or the salinity of a site changes, the landscape plant communities also change. When plants cannot survive, ponds develop and grow as tropical storms disperse organic sediments into the Lake. At Goose Point, the issue is not too much salinity because the marshes coexisted with the Lake for centuries or more. Salinity is a component of the mucky soils throughout most of the marsh but is highest near the Lake. Still, the average lake salinity, near Goose Point (see Figure 7) ranges between 3 and 4.5 parts per thousand.

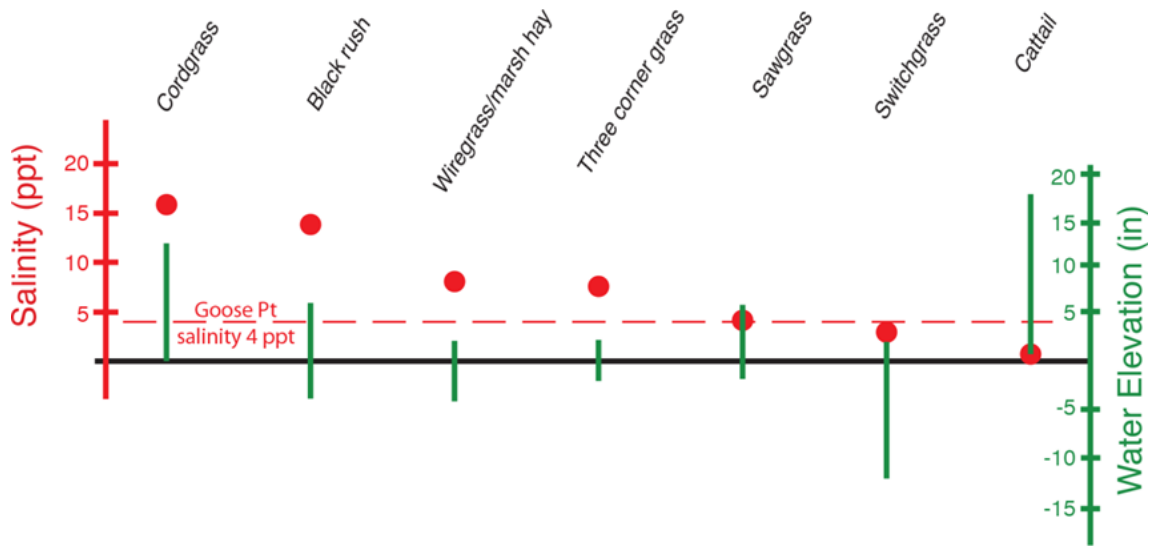
Figure 8. Optimum salinity and water depth range for marsh plants (modified after Spencer et al., 1992). The red horizontal line approximates the average salinity for Goose Point marsh from about 3.0 to 4.5 ppt (Georgiou et al., 2007). The red balls show the optimum salinity for individual species. The green bars show optimum water depth ranges for these individual species (Couvillion and Beck, 2011) noted that optimum salinities may not correspond to sustainable conditions in some marshes.

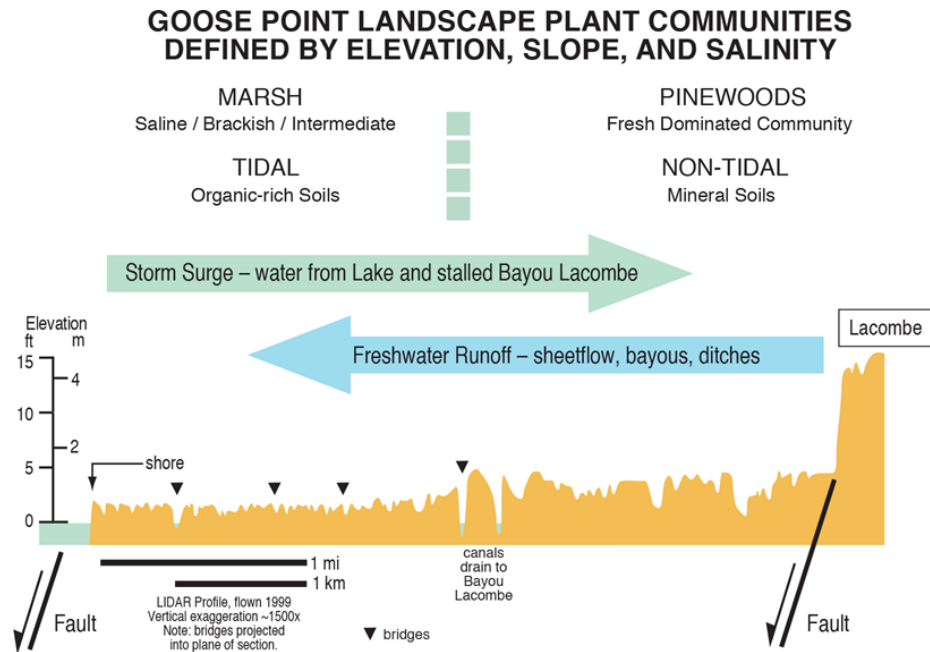
Figure 9. Goose Point LIDAR profile from the Lake to the Lacombe Fault (Wiltmuth, 2000). Couvillion and Beck (2013) modeled these marsh types and concluded that as relative sea level rise continues, marshes either migrate inland or collapse to open water in place. This marsh community has been migrating into the lower features interior to the pine flatwoods south of the Lacombe Fault for decades. Hurricane and tropical storm winds and surge greatly assist in dispersing seeds and viable plant pieces into the surrounding area.
